Class B Accident Report

Lady Kawhia

Mechanical Failure

Kawhia Harbour on 14 November 2004

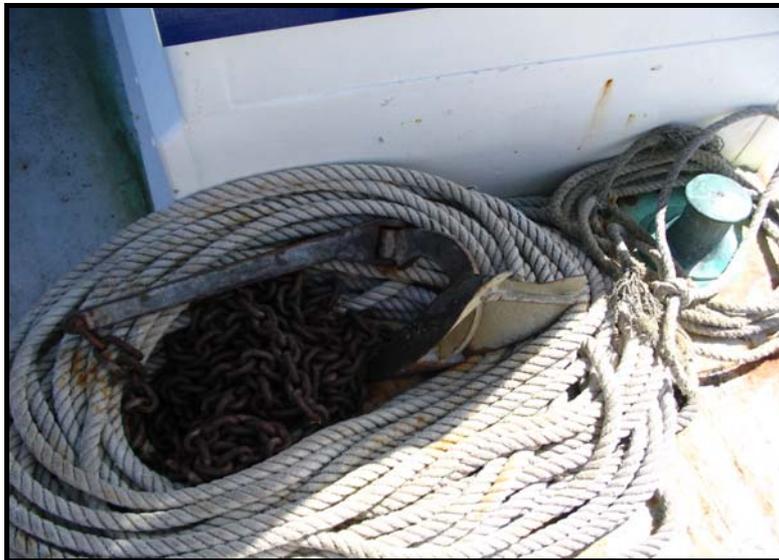
Main Anchor

When the anchors were recovered, it was found that they were fouled on a large commercial fishing net and in its associated traces. The anchors would not hold because of this.
