Class B Accident Report

Lady Kawhia

Mechanical Failure

Kawhia Harbour on 14 November 2004

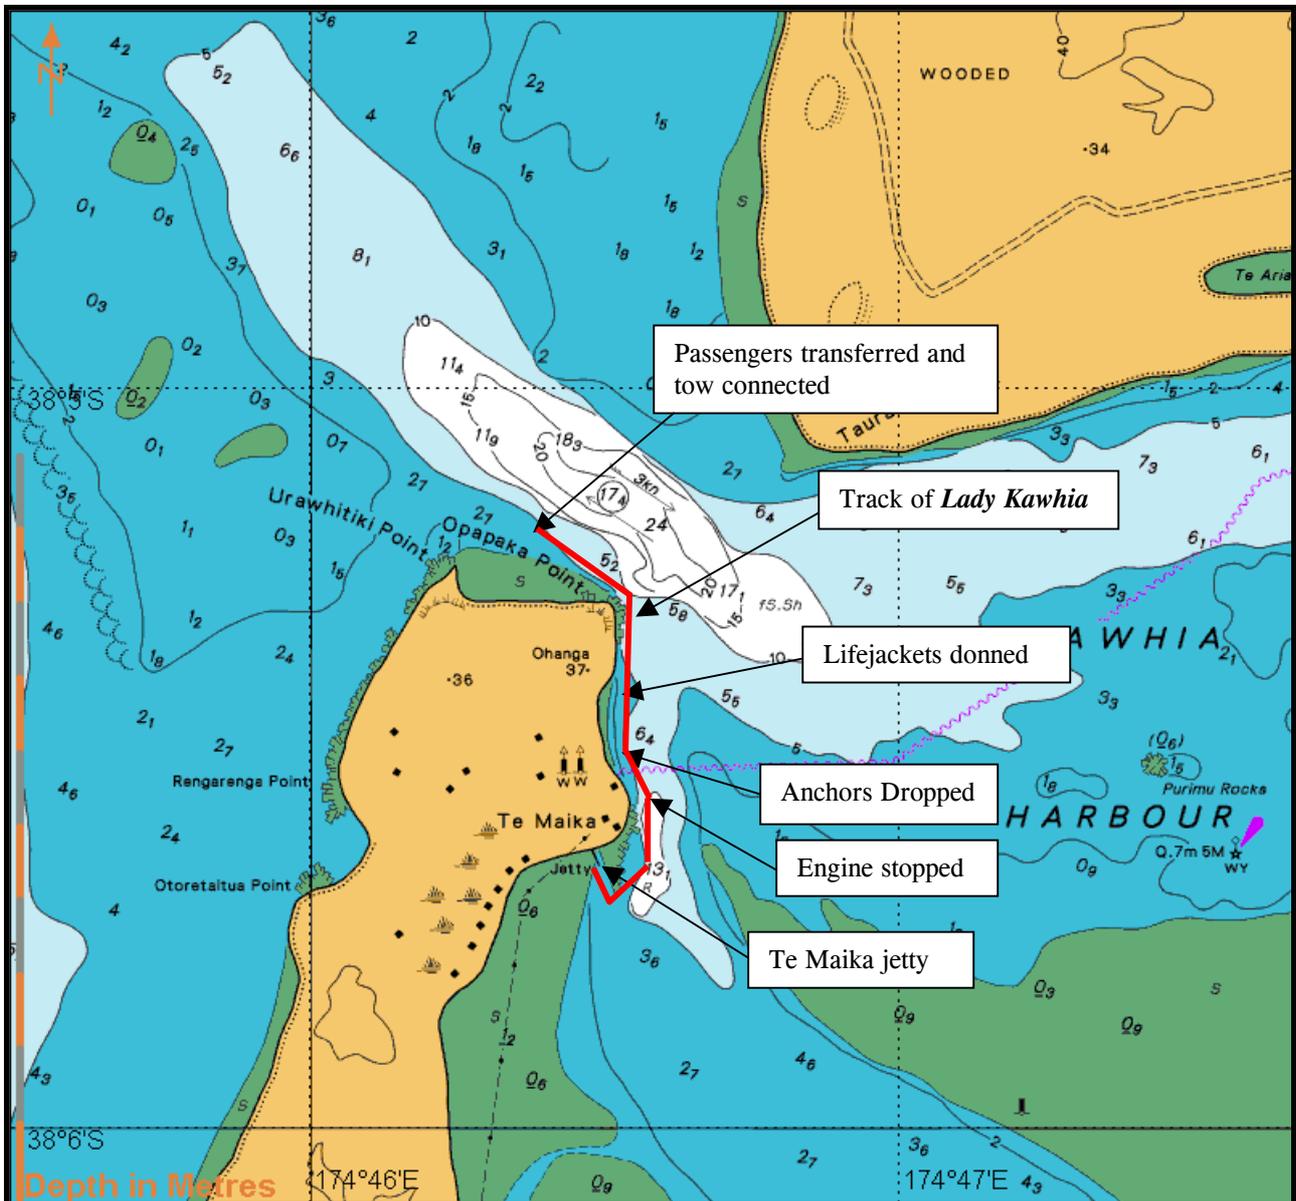
After the passengers embarked, *Lady Kawhia* departed Te Maika pier at approximately 1500 hours. Shortly afterwards, *Lady Kawhia's* engine failed. The engineer went to the engine room and soon discovered the fuel filters and fuel lines to be blocked, thus starving the engine of fuel.

Since the incident, the fuel lines have been unblocked and the filters replaced. The fuel in the tanks has been discarded and the tanks have been cleaned out. The engine has been run for approximately 30 hours without incident and there have been no further signs of fuel contamination.
